National Transportation Safety Board

Aircraft Accident Investigative Update

On January 26, 2020, at 0945 Pacific standard time (PST), a Sikorsky S-76B helicopter, N72EX, collided with hilly terrain near the city of Calabasas, California. The pilot and eight passengers were fatally injured, and the helicopter was destroyed by impact forces and fire. The helicopter was operated by Island Express Helicopters Inc. under Title 14 Code of Federal Regulations (CFR) Part 135 as an on-demand passenger visual flight rules (VFR) flight from John Wayne-Orange County Airport, (KSNA), Santa Ana, California, to Camarillo Airport, (KCMA), Camarillo, California.

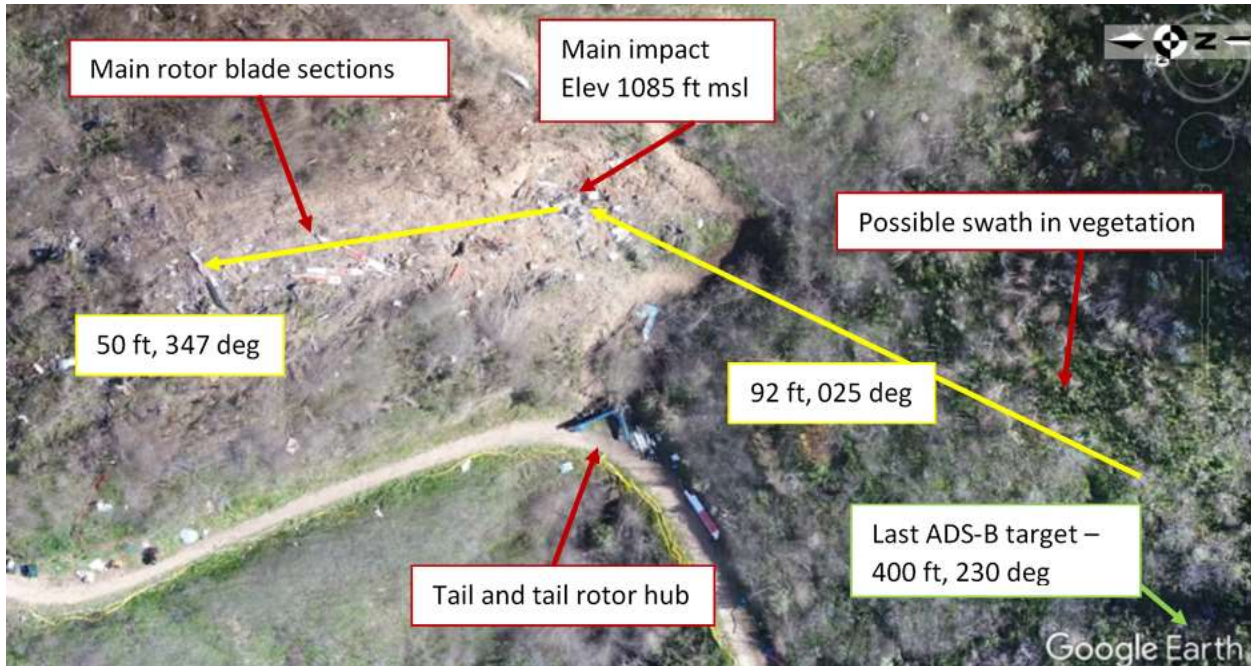
Figure 1a. Google Earth map of wreckage area – southern (directions reference true north)

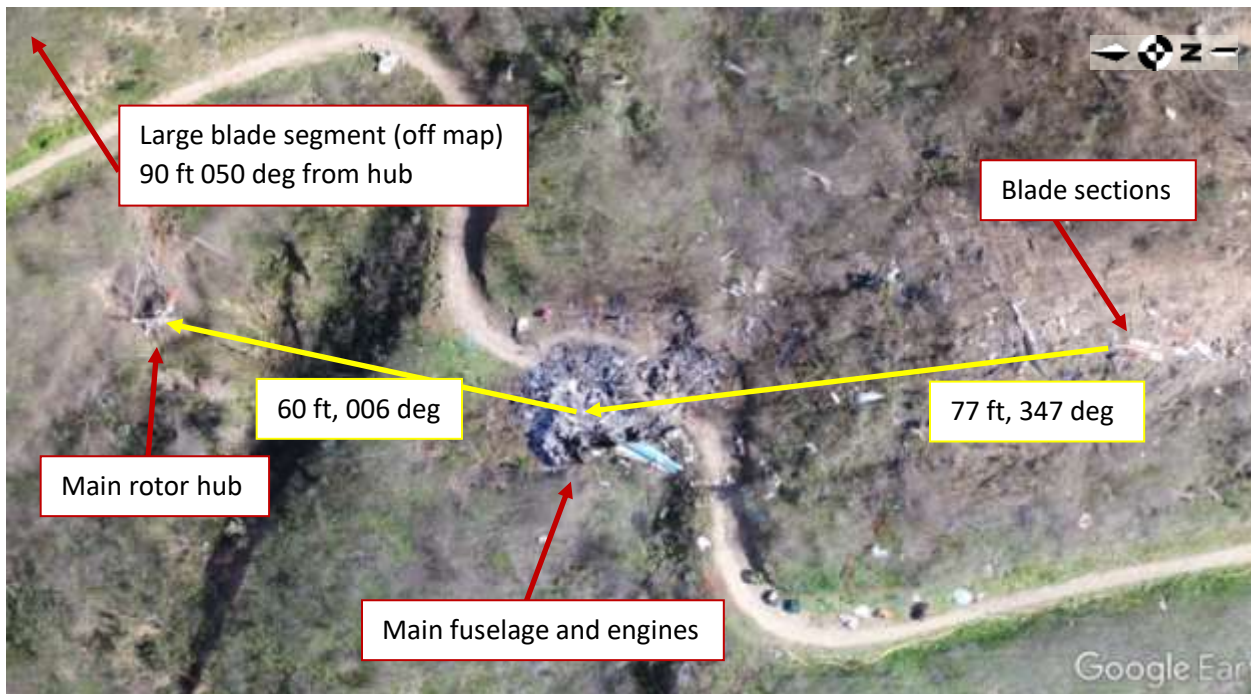
Figure 1b. Google Earth map of wreckage area – northern

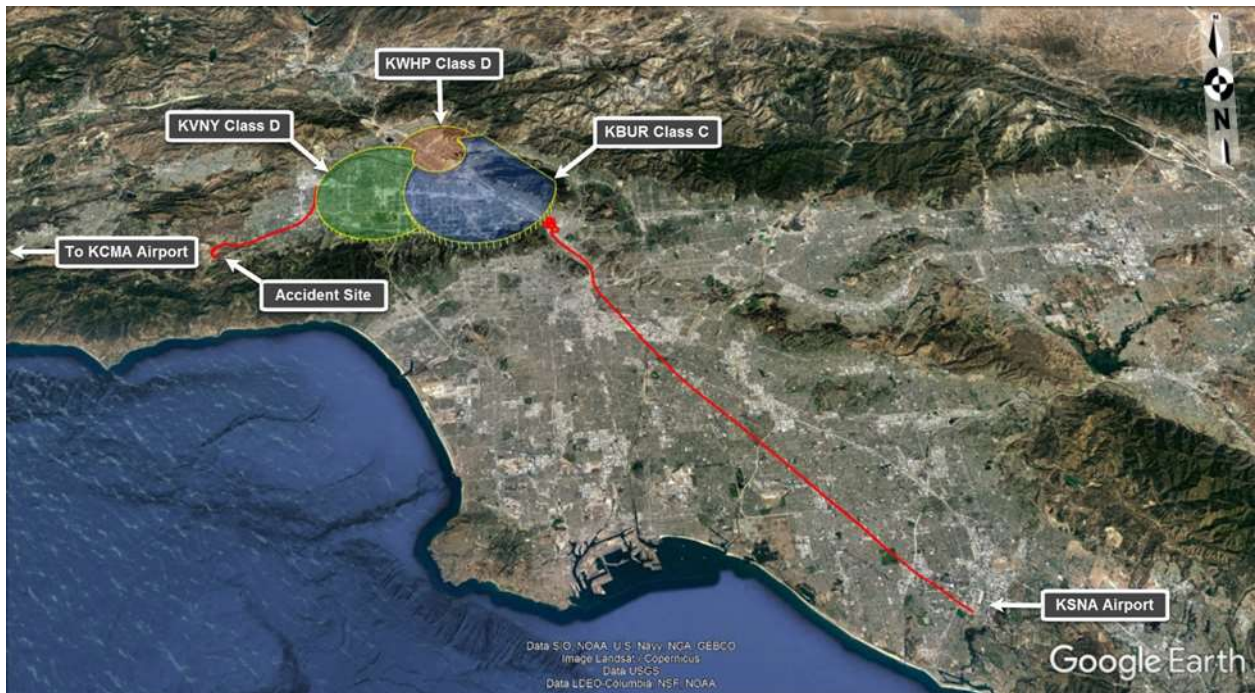
Radar/ADS-B data indicate the aircraft was climbing along a course aligned with Highway 101 just east of the Las Virgenes exit. Between Las Virgenes and Lost Hills Road, the aircraft reached 2,300 feet msl (approximately 1,500 feet above the highway, which lies below the surrounding terrain) and began a left turn. Eight seconds later, the aircraft began descending and the left turn continued. The descent rate increased to over 4,000 feet per minute (fpm), ground speed reached 160 knots. The last ADS-B target was received at 1,200 feet msl approximately 400 feet southwest of the accident site.

Figure 2a. Overall Radar/ADS-B track of N72EX

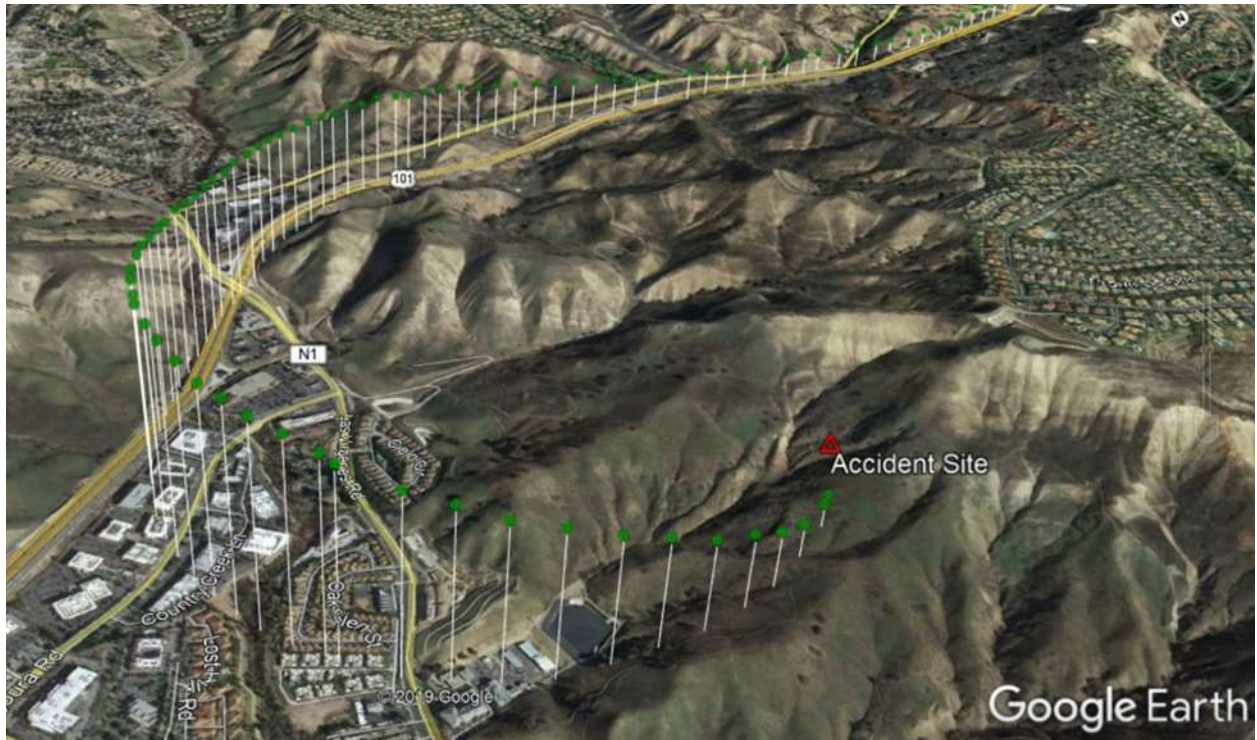
Figure 2b. Zoomed in depiction of ADS-B returns of last 1 minute of flight.

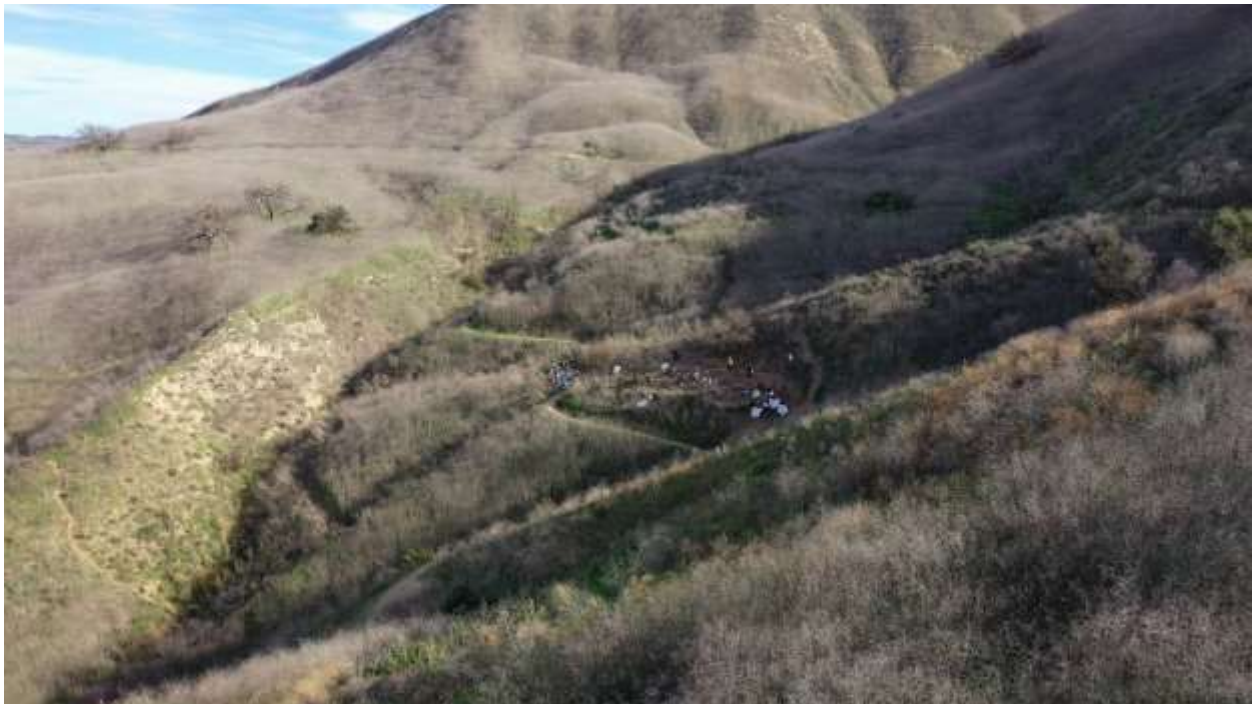
Figure 3. Still image from drone video duplicating the flightpath of N72EX at position/altitude of last ADS-B target

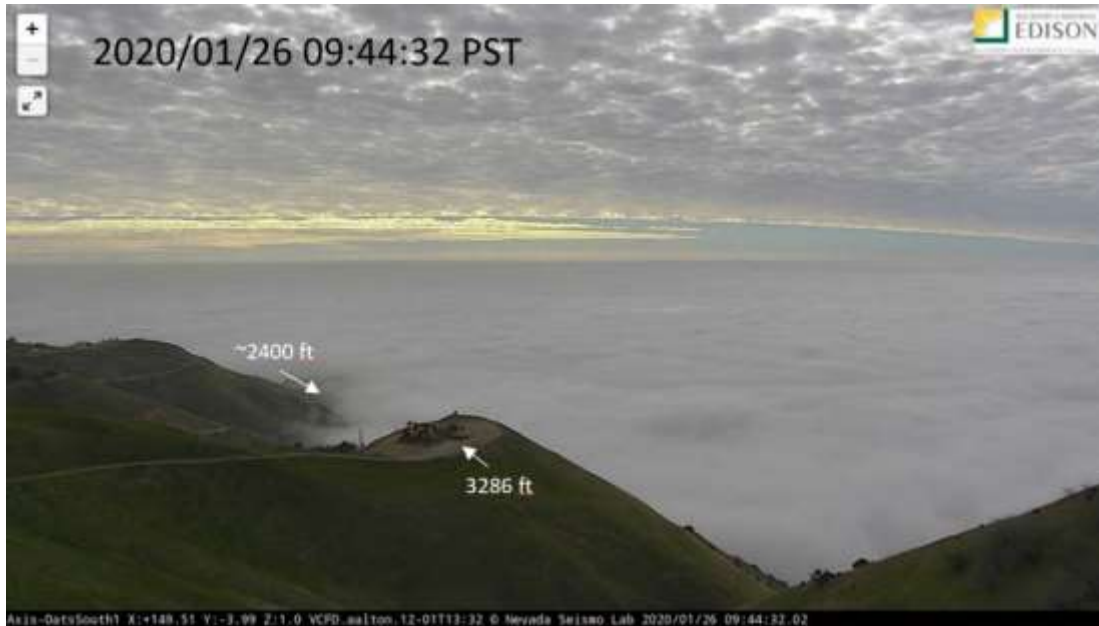
An ALERTWildfire camera image (figure 4) taken at 0944 PST looking southeast toward the city of Van Nuys, as publicized on the National Weather Service (NWS) Los Angeles Twitter account, depicted the top of the cloud layer to the east of the accident site. The NWS analyzed the top of the cloud layer to be about 2,400 feet above mean sea level near the terrain in the foreground of the image.

Figure 4. Camera image from 0944 PST

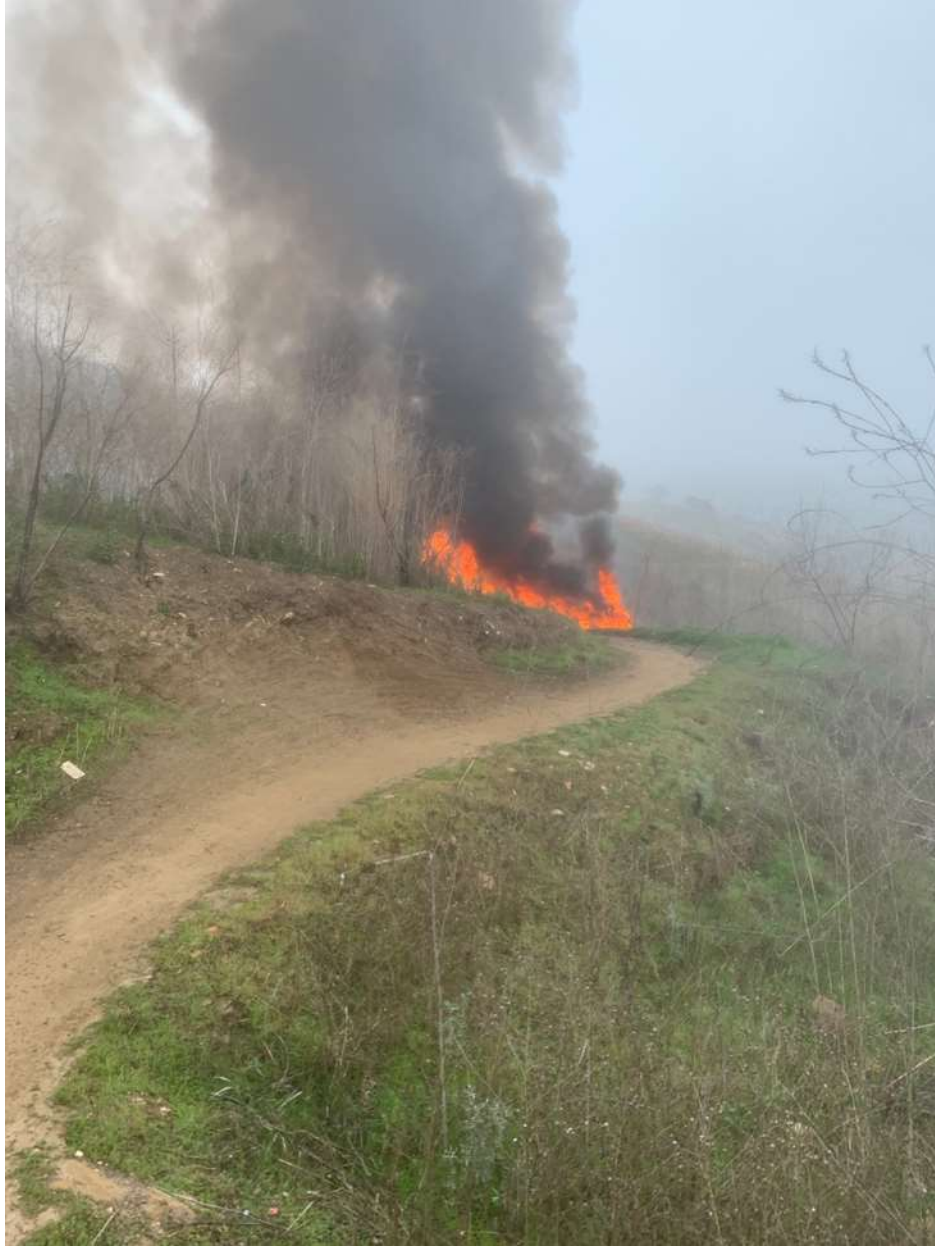
Videos and photos taken by the public in the area of the accident also depict fog and low clouds obscuring the hilltops. Figure 5a was taken by a witness on the mountain bike trail about 0950. The witness stated that the area was surrounded by mist. He said he began to hear the sound of a helicopter, which he described as appropriate for a helicopter flying while in a powered condition. He perceived the sound getting louder and saw a blue and white helicopter emerge from the clouds passing from left to right directly to his left. He judged it to be moving fast, travelling on a forward and descending trajectory. It started to roll to the left such that he caught a glimpse of its belly. He observed it for 1 to 2 seconds, before it impacted terrain about 50 feet below his position.

Figure 5a. Witness photo of accident site and weather conditions.

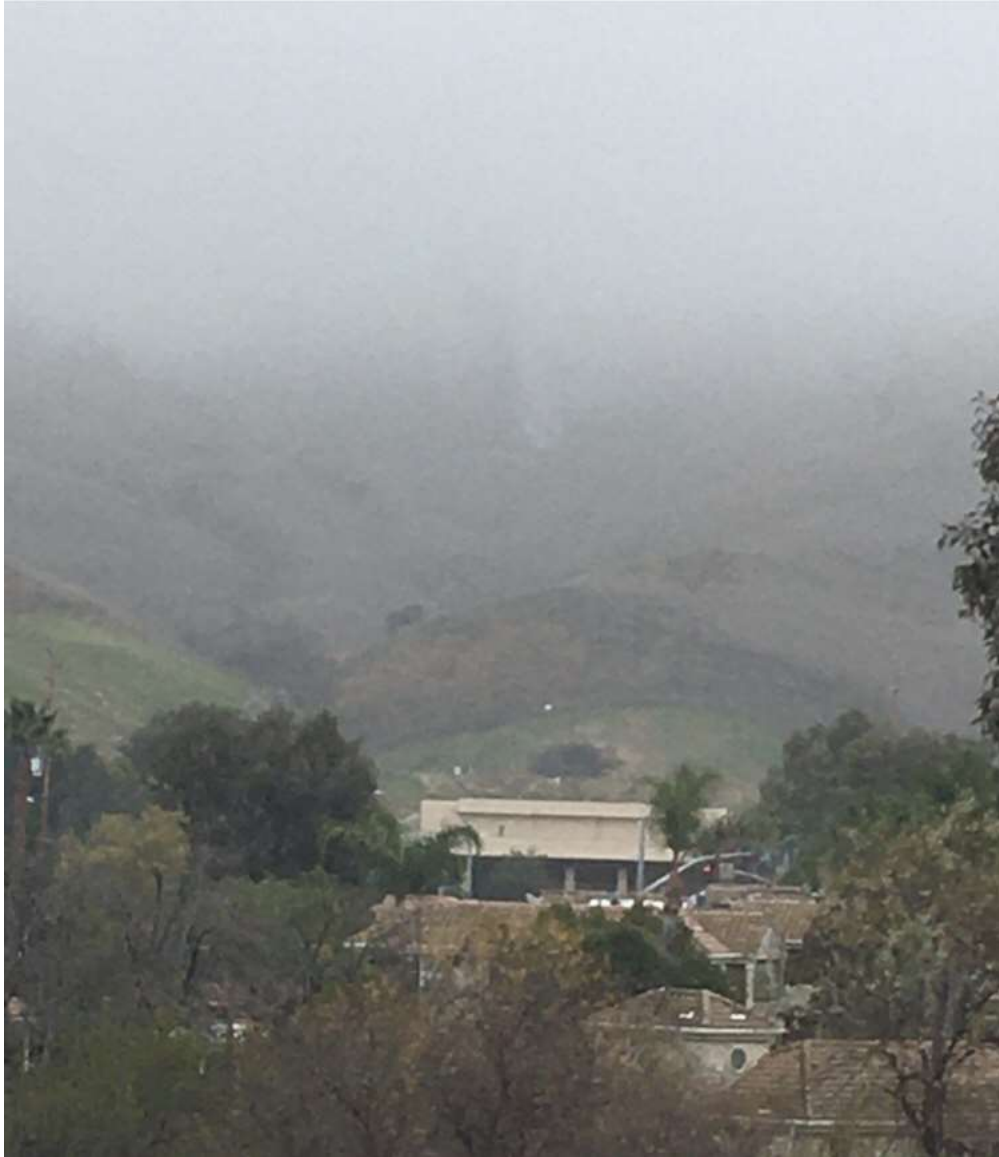
Figure 5b was taken by a nearby resident about 5 minutes after the accident from a location about 4,000 feet west of the site at an elevation of 750 feet msl.

Figure 5b. Resident photograph.

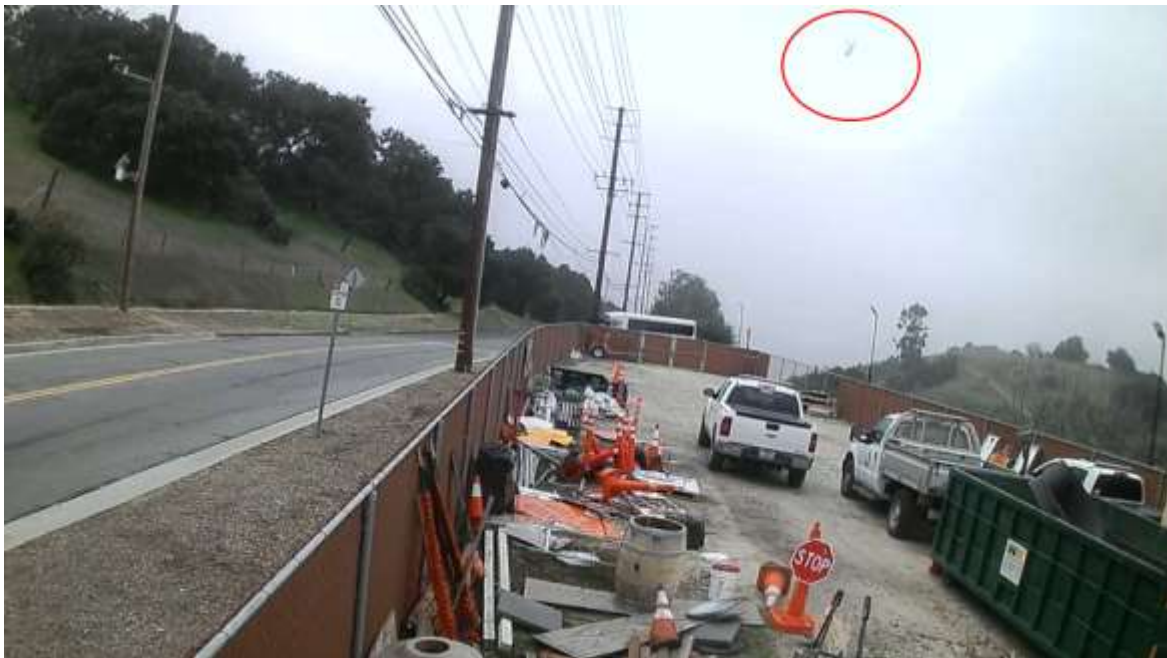
Figure 6 is a still frame from a security video obtained from a road maintenance yard adjacent to Moreau Road and Highway 101 depicting the helicopter proceeding westward along the highway and disappearing into the clouds.

Figure 6. Still frame from security video showing N72EX flying into clouds (circled in red)
