National Transportation Safety Board

Aircraft Accident Investigative Update

On January 26, 2020, at 0945 Pacific standard time (PST), a Sikorsky S-76B helicopter, N72EX, collided with hilly terrain near the city of Calabasas, California. The pilot and eight passengers were fatally injured, and the helicopter was destroyed by impact forces and fire. The helicopter was operated by Island Express Helicopters Inc. under Title 14 Code of Federal Regulations (CFR) Part 135 as an on-demand passenger visual flight rules (VFR) flight from John Wayne-Orange County Airport, (KSNA), Santa Ana, California, to Camarillo Airport, (KCMA), Camarillo, California.

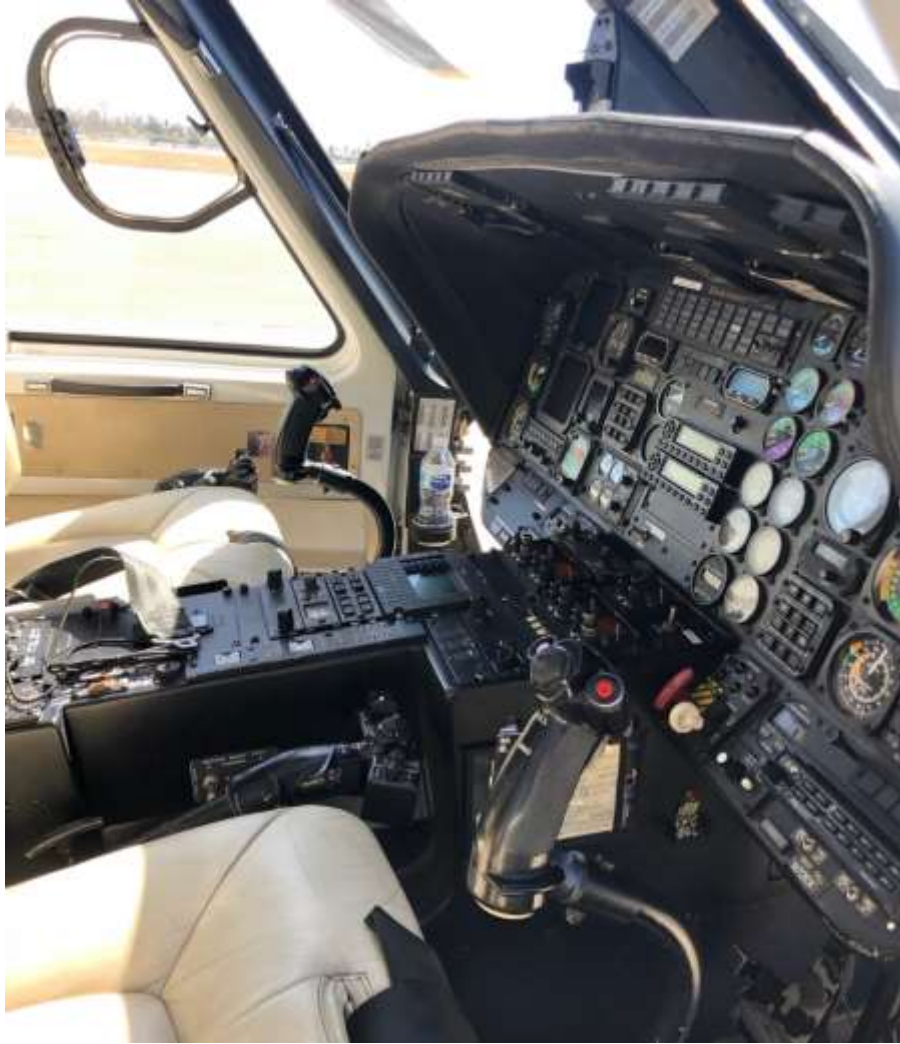
Figure 8. Photo of N72EX cockpit

The helicopter was not equipped with a flight data recorder or cockpit voice recorder (CVR) nor was it required to be for the accident flight. The helicopter was equipped with a four-axis automatic flight control system, electronic flight instrument system, radio altimeter, and ADS-B transponder. It was also equipped with a flight management system (FMS). The airworthiness group retained the FMS computer to examine it for any available recorded data stored in memory, and also retained two flight control computers, four gyros, and the standby attitude indicator for further examination. A number of personal electronic devices were recovered from the wreckage and will be examined for any relevant data.
